Bel Air Dam Removal

Community Meeting

December 5, 2023

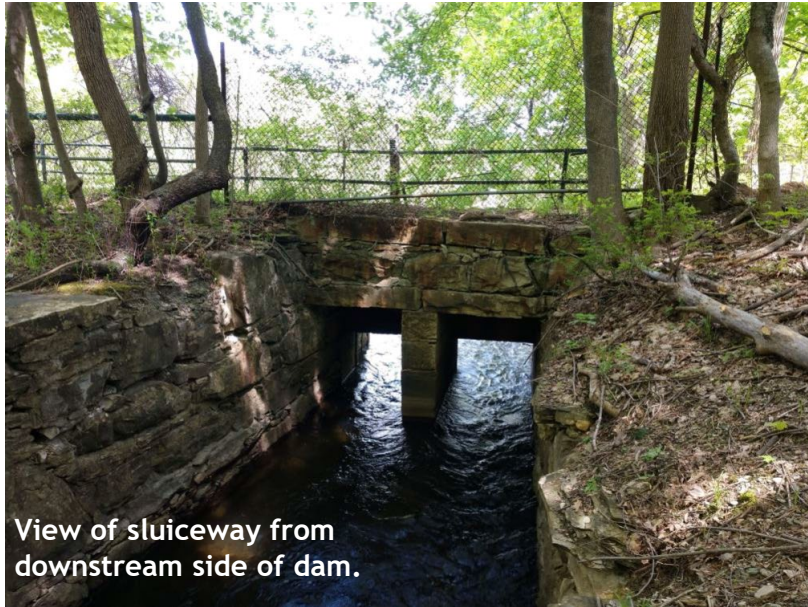
View of sluiceway from downstream side of dam.

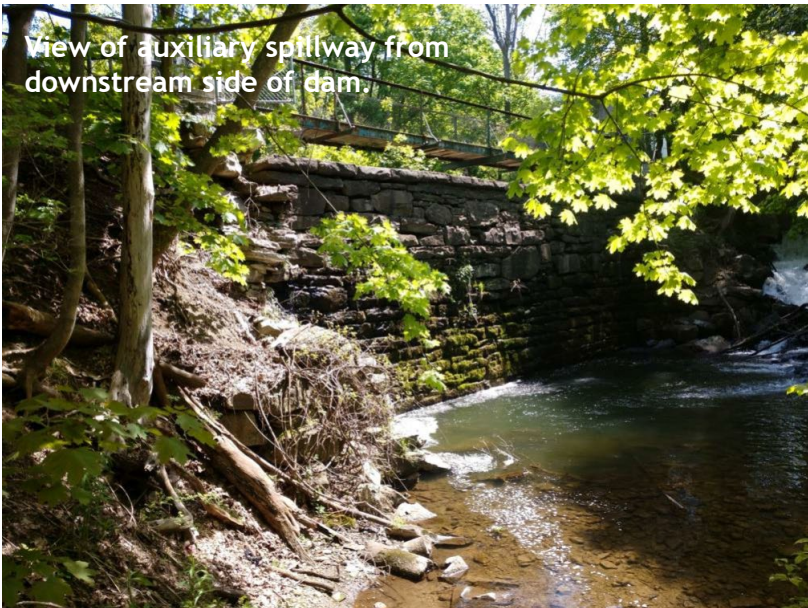
View of auxiliary spillway from downstream side of dam.

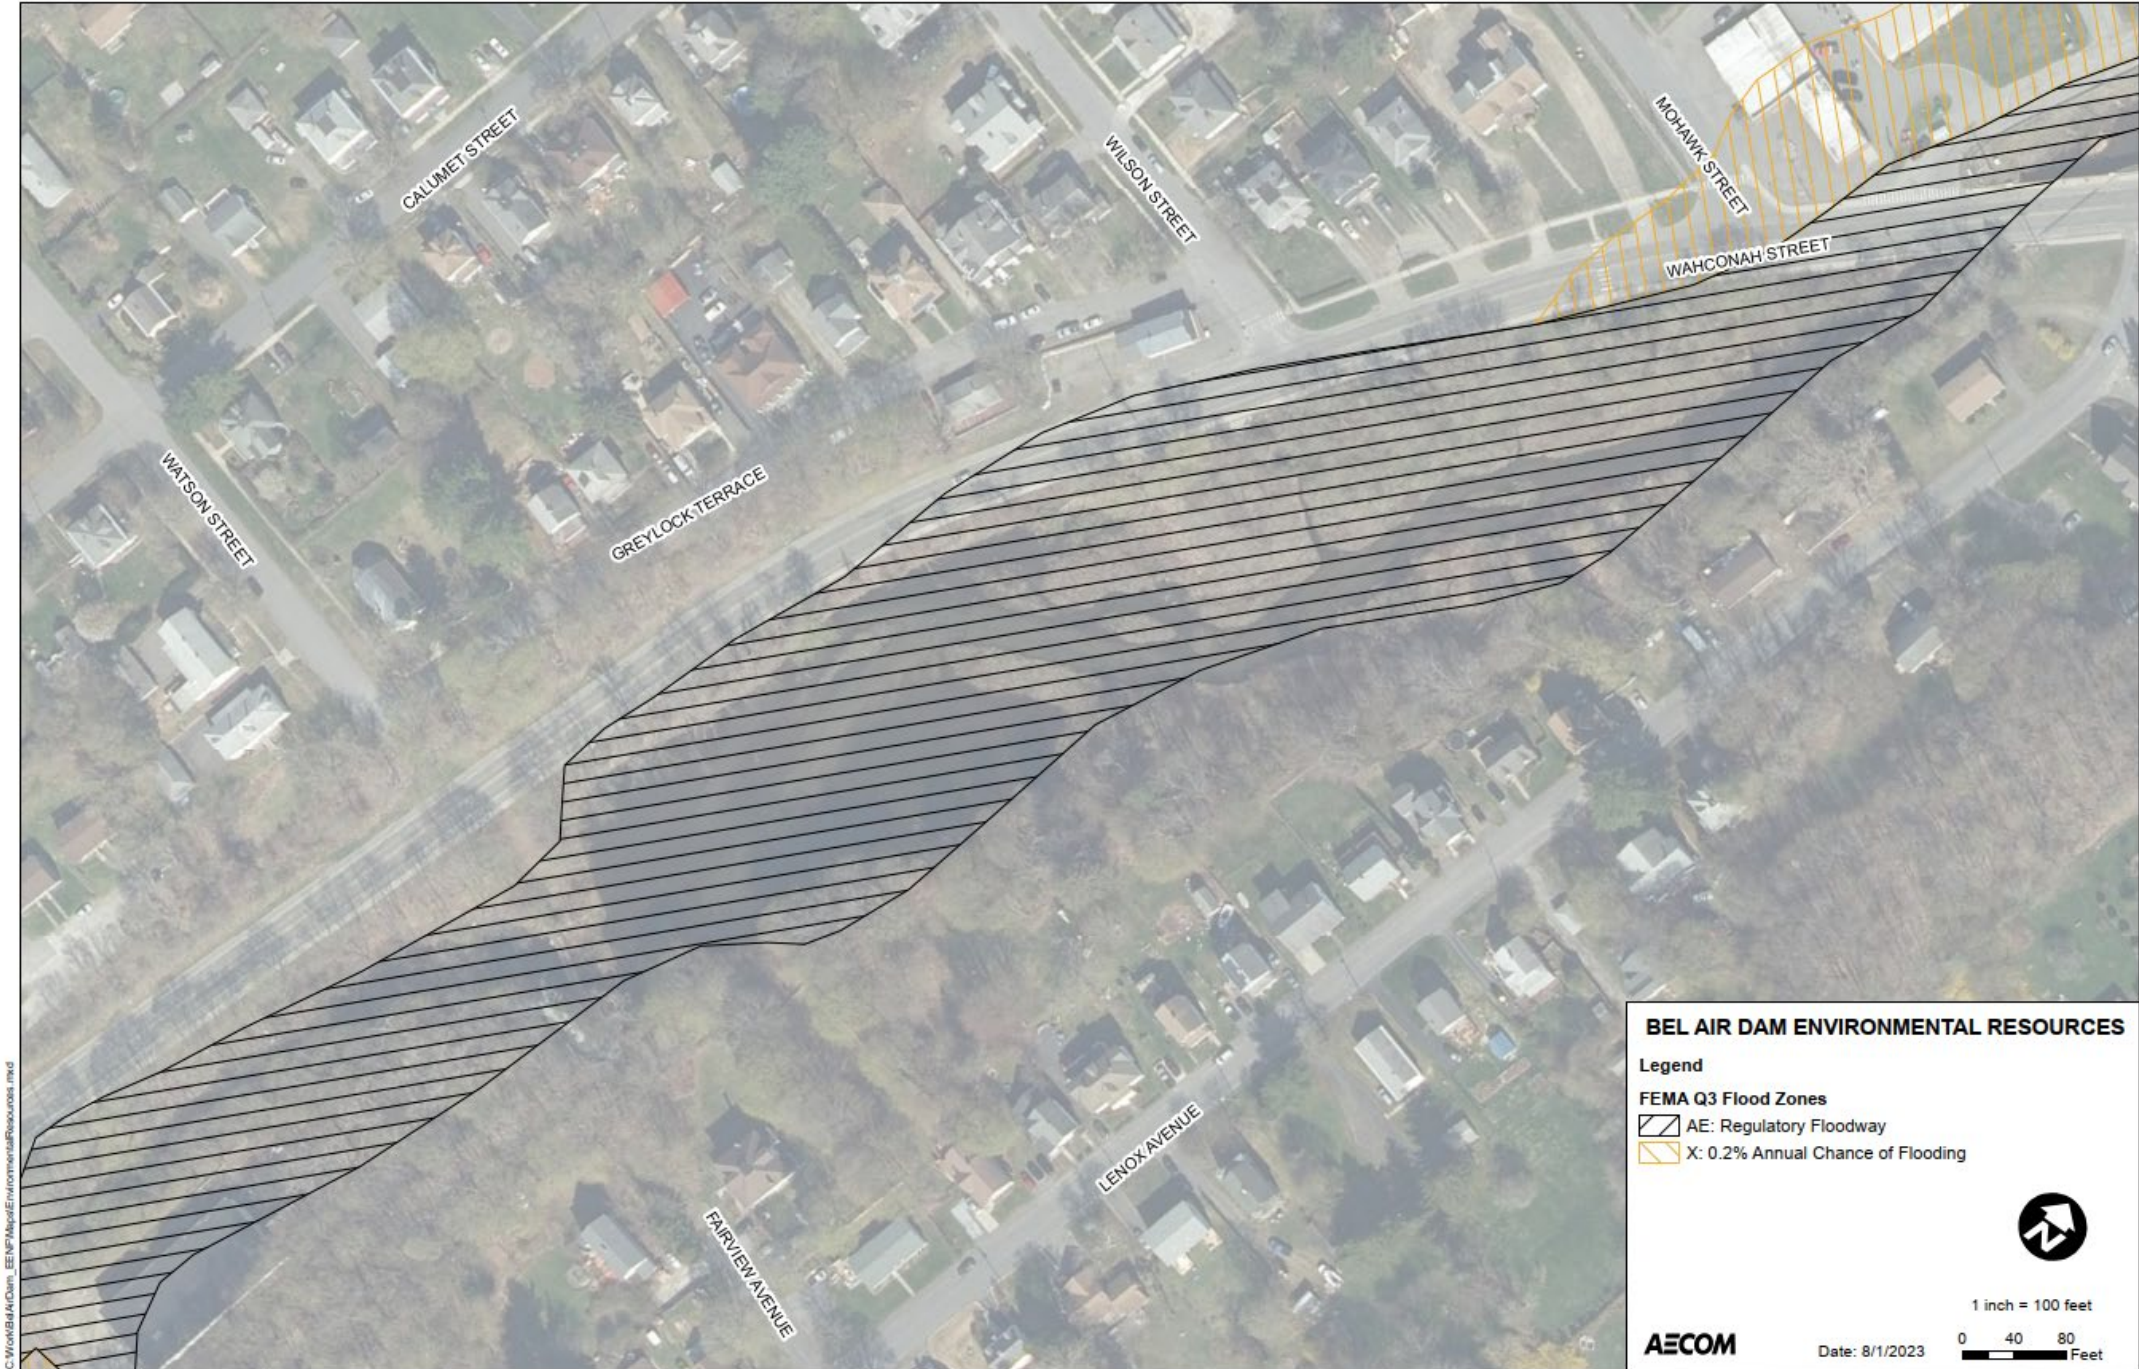
BEL AIR DAM ENVIRONMENTAL RESOURCES

- FEMA Q3 Flood Zones**
- AE: Regulatory Floodway
 - X: 0.2% Annual Chance of Flooding

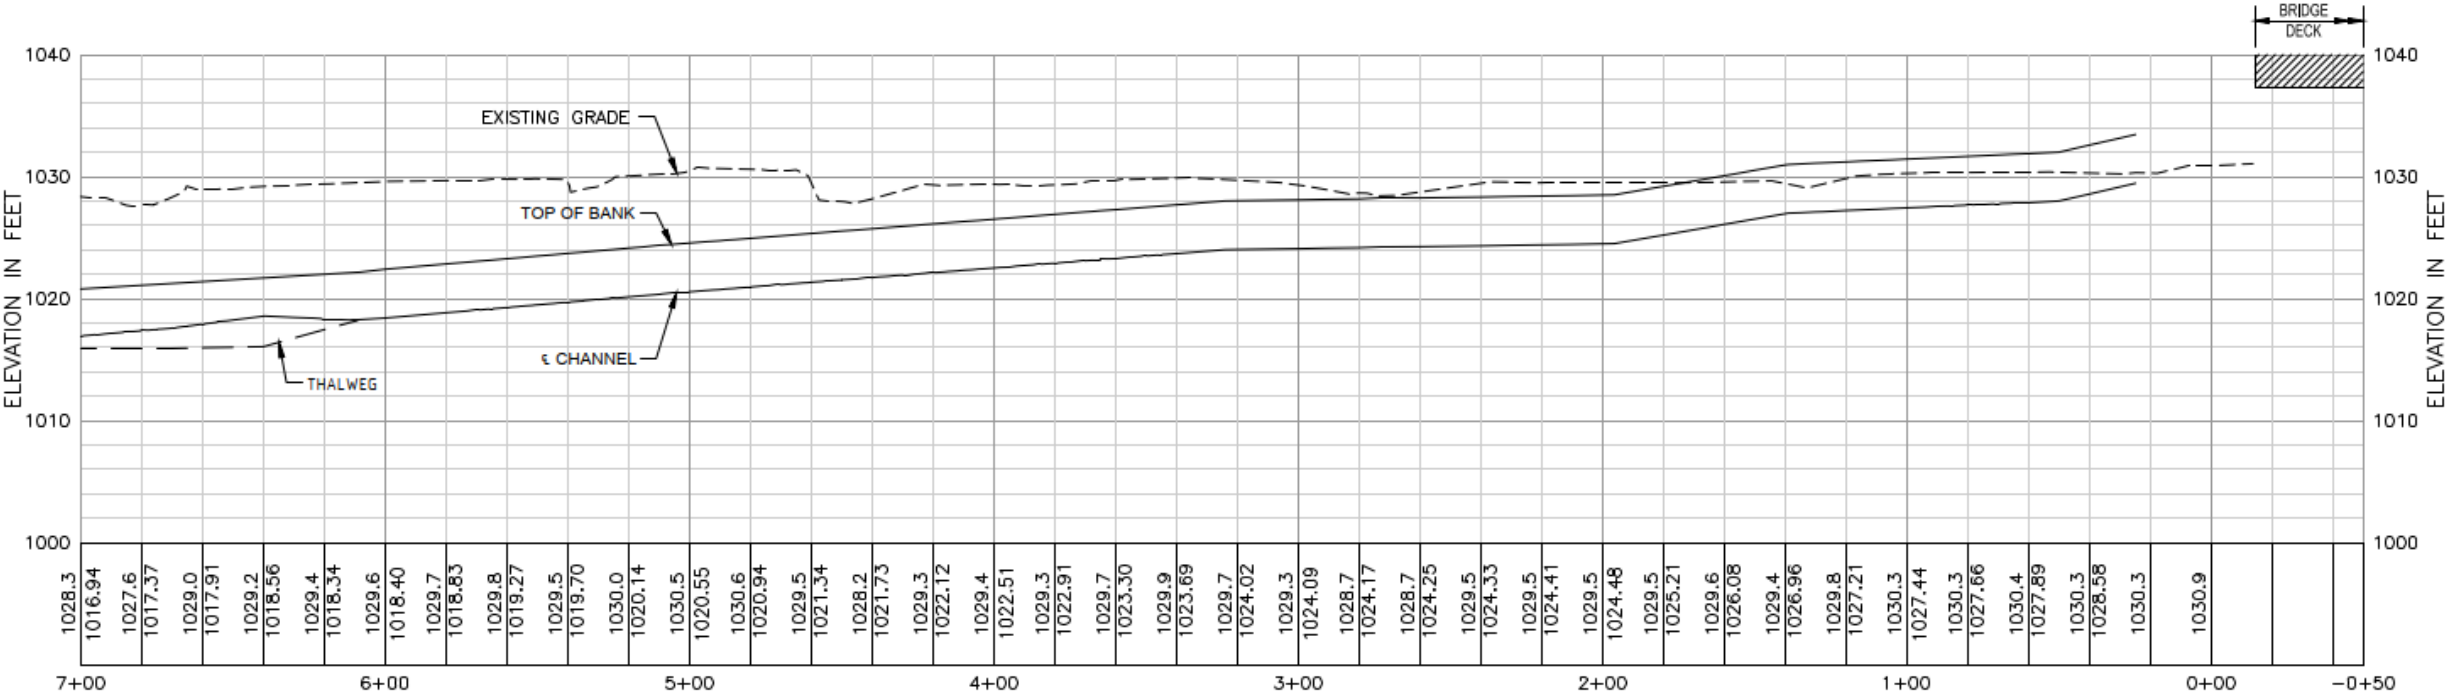
Current Working Draft of Restored Stream Profile

PROFILE - BEL AIR CHANNEL

SCALE: 1"=40' HORZ
1"=10' VERT

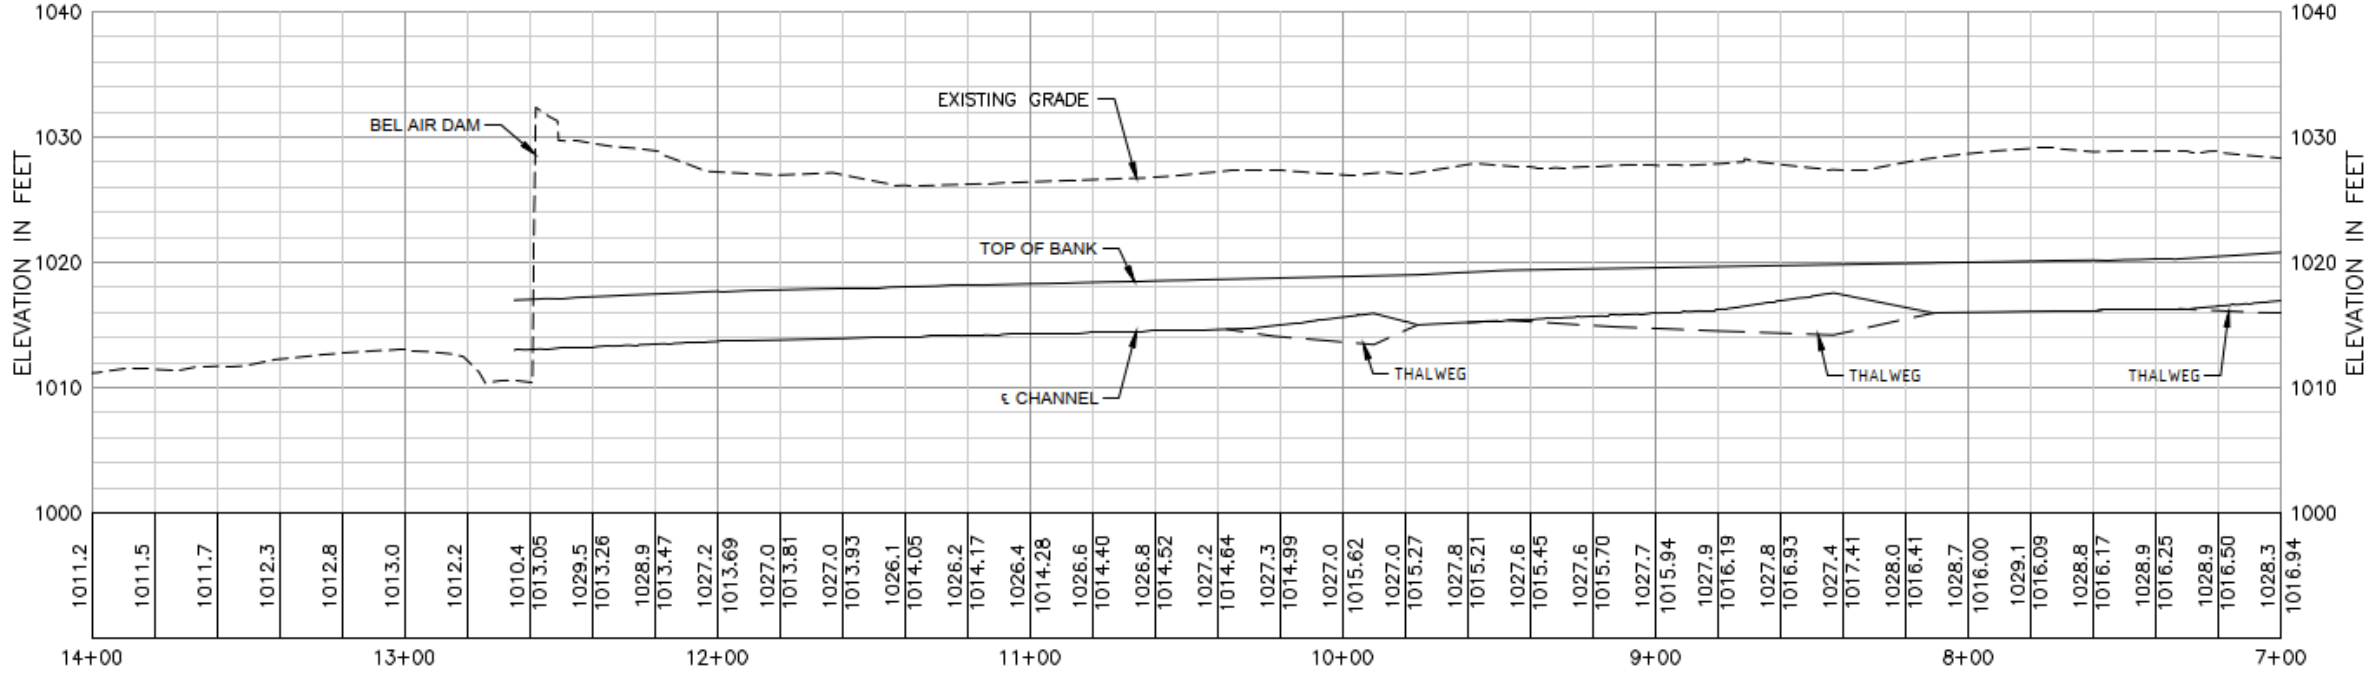
Current Working Draft of Restored Stream Profile

PROFILE - BEL AIR CHANNEL

SCALE: 1"=40' HORZ
1"=10' VERT

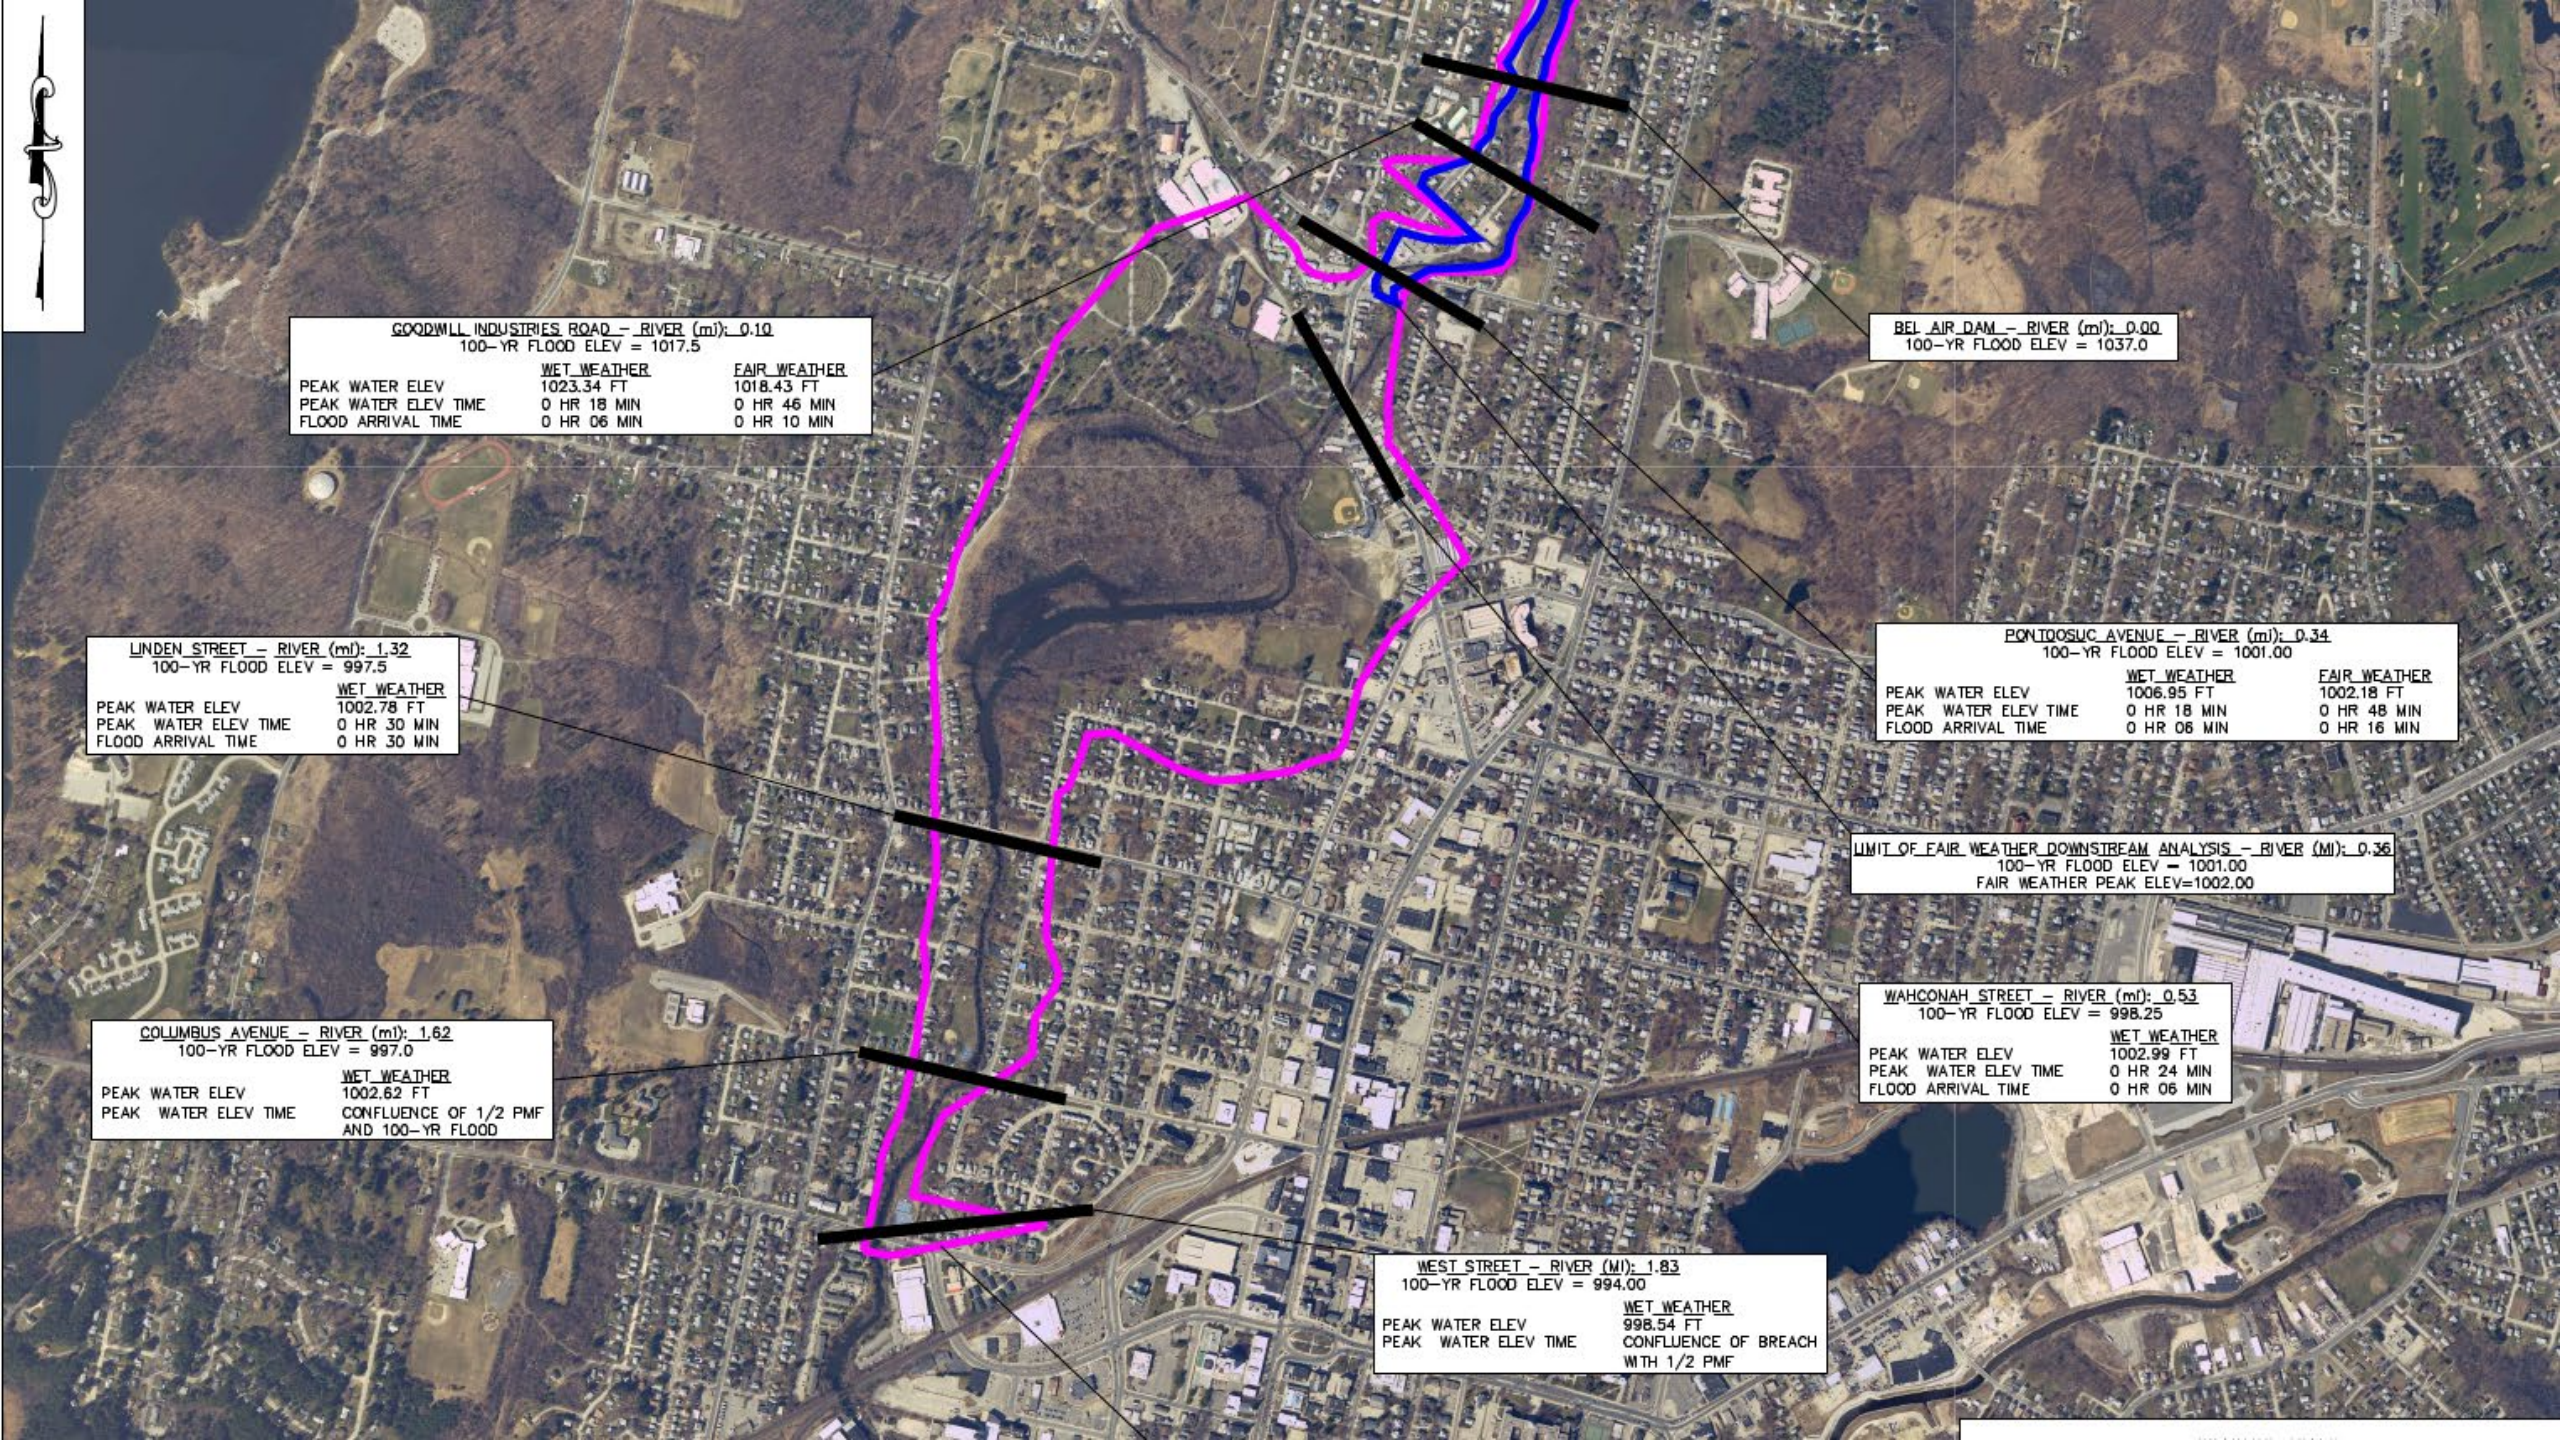
GOODWILL INDUSTRIES ROAD - RIVER (mi): 0.10
 100-YR FLOOD ELEV = 1017.5

WET WEATHER	FAIR WEATHER
PEAK WATER ELEV	1023.34 FT	1018.43 FT
PEAK WATER ELEV TIME	0 HR 18 MIN	0 HR 46 MIN
FLOOD ARRIVAL TIME	0 HR 06 MIN	0 HR 10 MIN

BEL AIR DAM - RIVER (mi): 0.00
 100-YR FLOOD ELEV = 1037.0

WET WEATHER
PEAK WATER ELEV	1002.78 FT
PEAK WATER ELEV TIME	0 HR 30 MIN
FLOOD ARRIVAL TIME	0 HR 30 MIN

WET WEATHER	FAIR WEATHER
PEAK WATER ELEV	1006.95 FT	1002.18 FT
PEAK WATER ELEV TIME	0 HR 18 MIN	0 HR 48 MIN
FLOOD ARRIVAL TIME	0 HR 06 MIN	0 HR 16 MIN

WET WEATHER
PEAK WATER ELEV	1002.99 FT
PEAK WATER ELEV TIME	0 HR 24 MIN
FLOOD ARRIVAL TIME	0 HR 06 MIN
