The objective of this project is the full removal of Bel Air Dam and the elimination of the impoundment to address the current public safety and deteriorating infrastructure concerns. Please see the uploaded Project Narrative.

Bel Air Dam is part of the Massachusetts Department of Conservation and Recreation (MassDCR) Office of Dam Safety's (ODS) pilot Abandoned Dams program. As part of this program, MassDCR is seeking to address safety concerns pertaining to dams in the Commonwealth that have no identifiable owner. In general, MassDCR seeks to partner with a municipality or other interested party in order to implement a Repair Alternative. If a municipality or other interested party will commit to achieving property ownership, then MassDCR will implement required dam repairs prior to property acquisition by others. Given no municipal or private party interest in achieving dam ownership, the Full or Partial Removal Alternatives are preferred. In the case of Bel Air Dam, neither the City of Pittsfield nor any other interested party has expressed willingness to take ownership of the dam; therefore, the MassDCR ODS is proposing to remove the dam. The proposed project will remove the

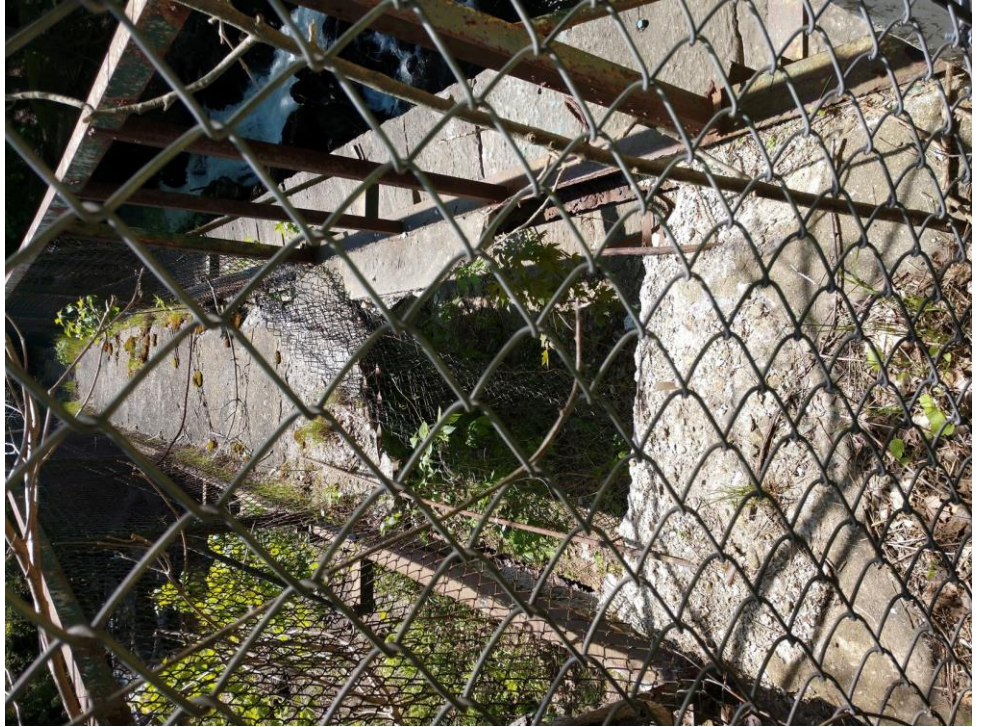
Photo No. 2

View of pedestrian bridge deterioration looking from right side of dam

A pedestrian bridge crosses above the auxiliary spillway and is constructed of steel beams and a concrete deck. The bridge has been condemned by the City of Pittsfield and is fenced off due to the deterioration of the structural elements being deemed to make the bridge unsafe for occupants. A gated chain link fence and no trespassing signs restrict access to the bridge. Debris has accumulated along the auxiliary spillway around the concrete piers supporting the bridge.
